# Tri-County Water Board of Management Agenda

# Building Condition Assessment & Capital Reserve Fund

## Service Buildings in West Lorne Ontario 8662 Graham Road, West Lone, Ontario

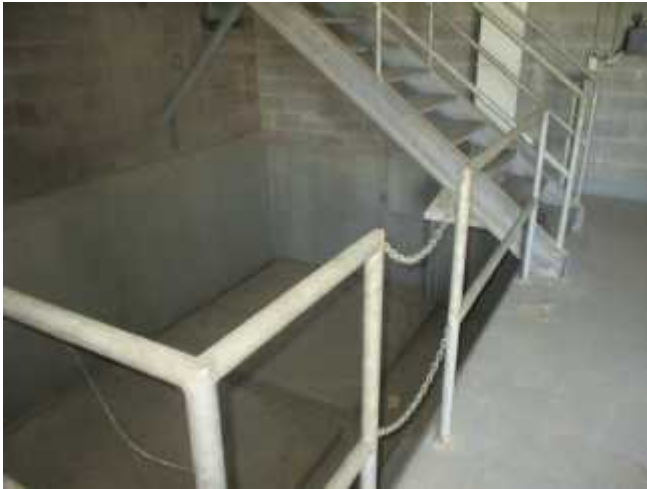
Concrete sub structural components were noted in fair to good condition.

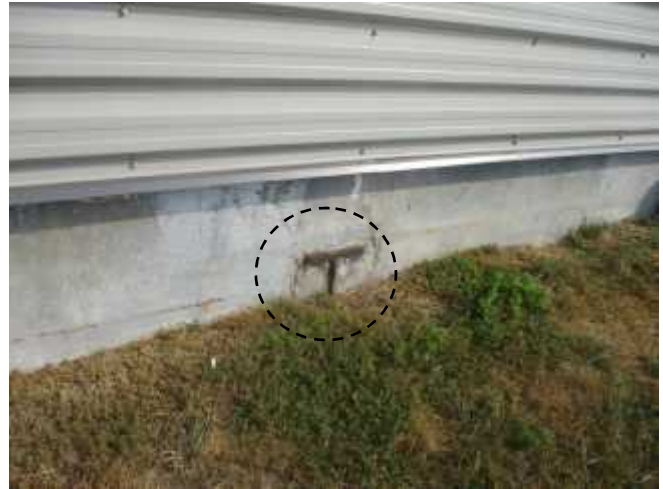
Exposed corroded steel was noted imbedded at the foundation wall of Building A. Epoxy coating may be considered.

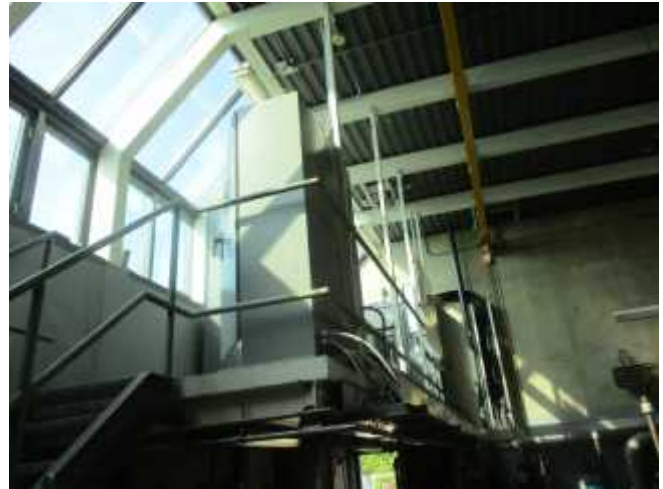
The steel framing of building B were noted to be in good condition.

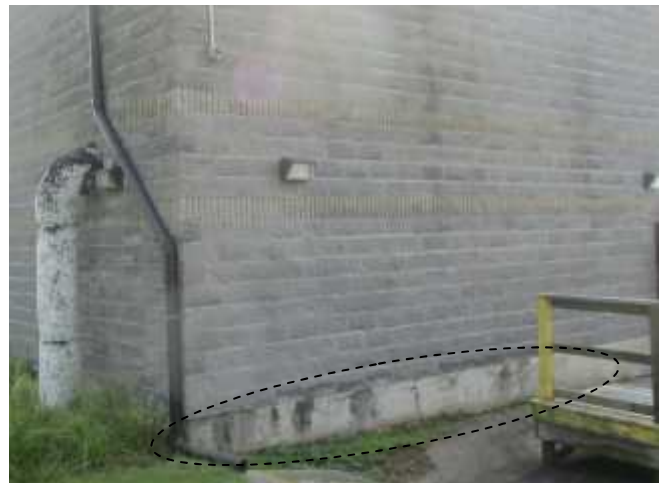
Cracks and staining on the exterior face of the west wall of Building B.

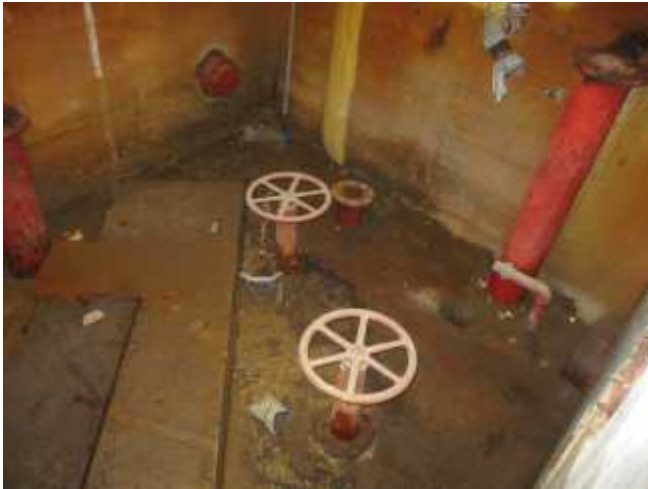
The basement of Building C was noted to be wet.

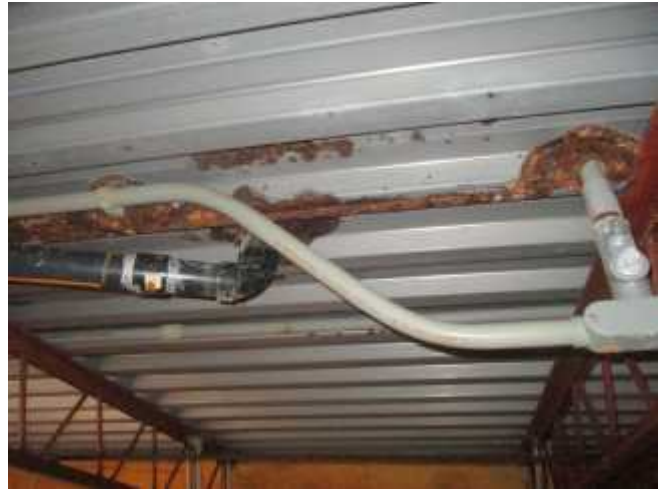
Corrosion was noted on the underside of the floor decking.

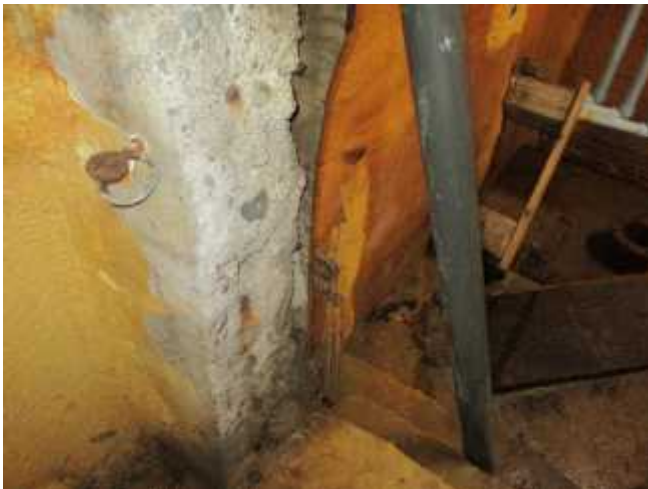
Water infiltration was noted within the basement of Building C.

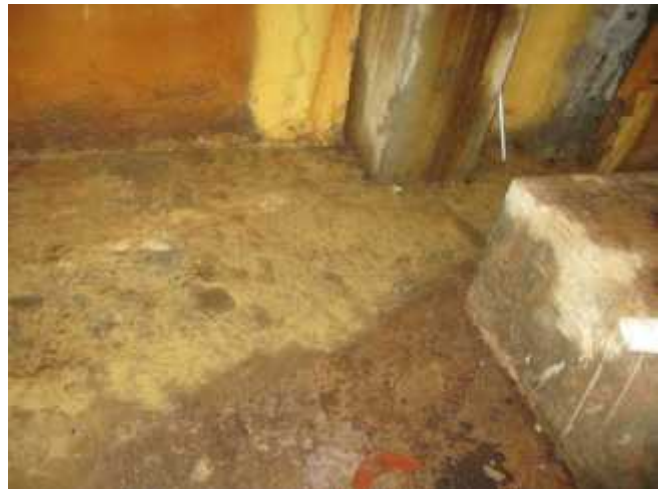
Surface deterioration was noted at the basement floor slab.

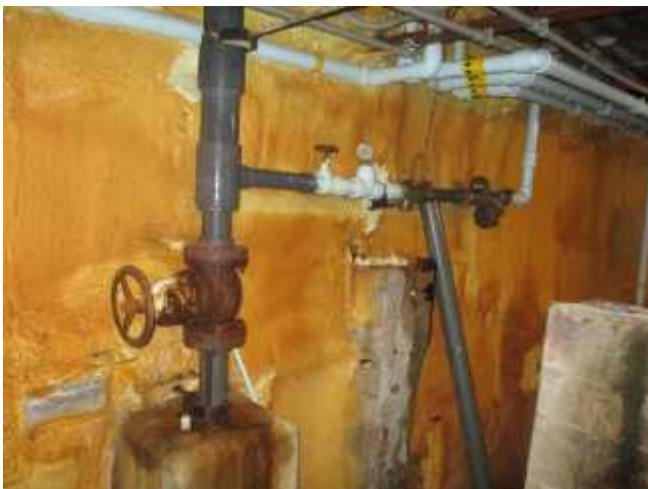
Corroding piping and valves noted in the basement of Building C.

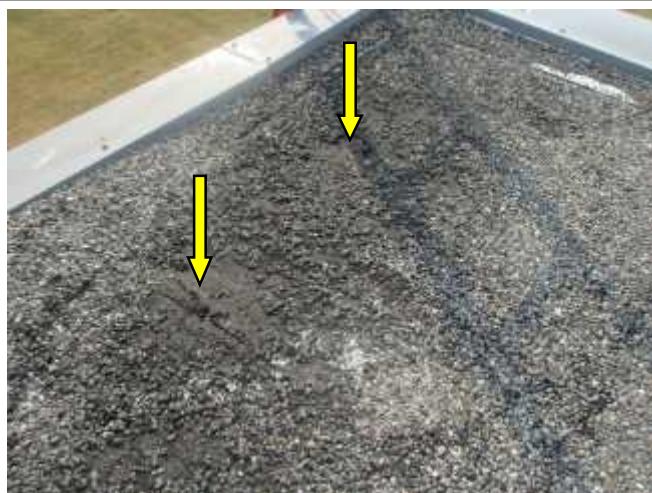
Exposed deteriorated membrane was noted on the southwest corner of the roof.

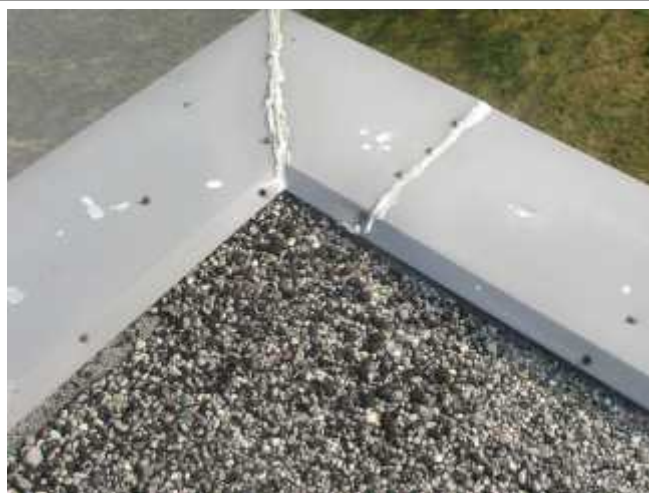
Hardened and deteriorated sealants were noted on the joints of parapet flashing.

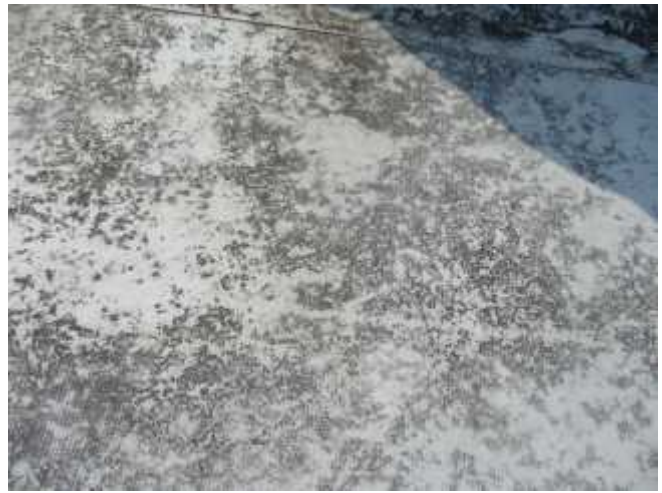
Deteriorated surface of the PVC membrane.

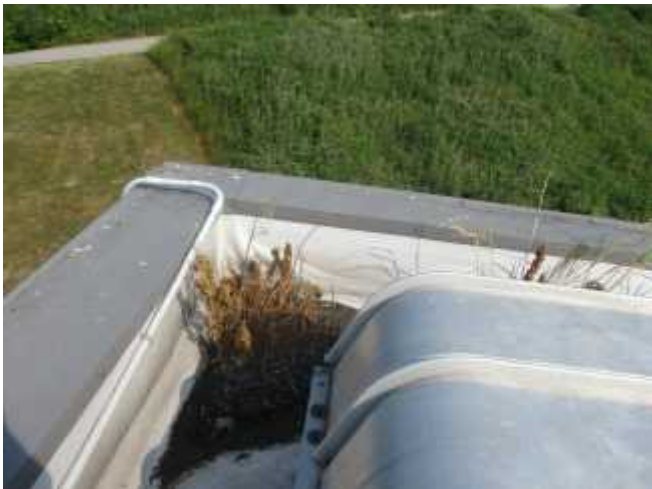
Debris accumulation and growth on the roof.

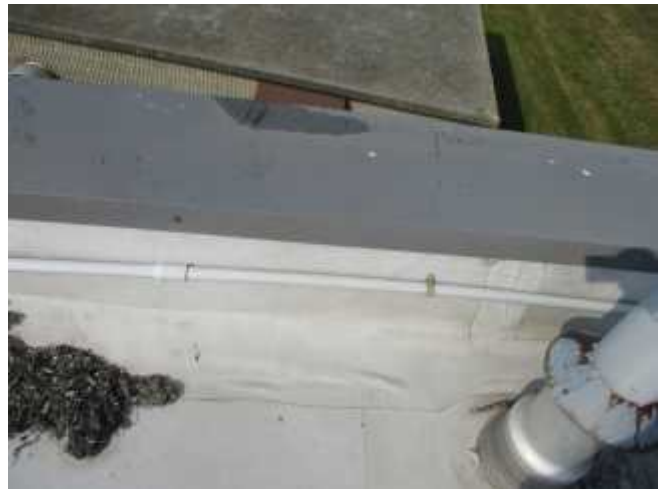
Wrinkled and tented membrane noted along the roof edge.

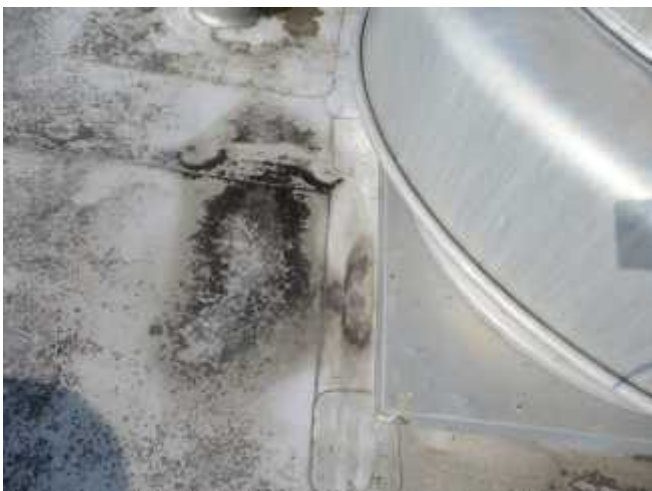
Ponding water and deteriorated membrane atop the roof.

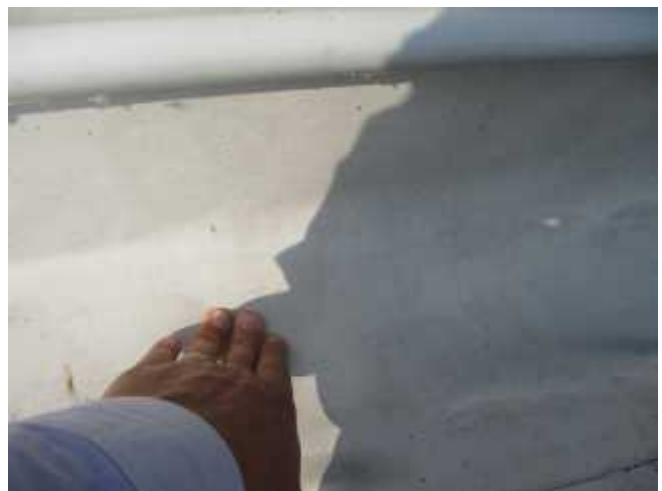
Tenting was noted to be severe along the west edge.

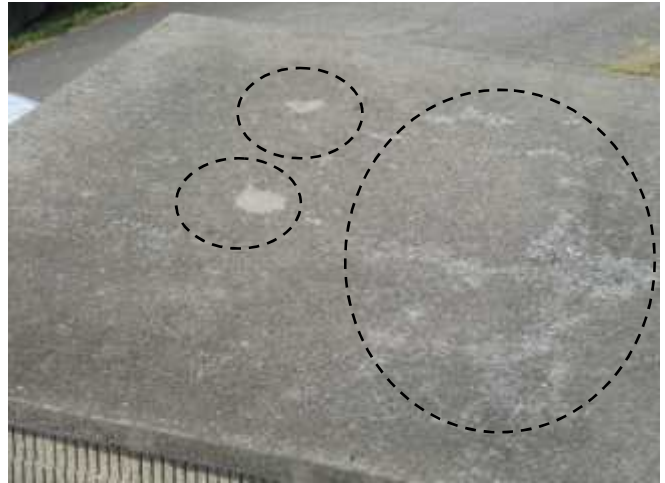
Evidence of previous repairs and damaged concrete decking was noted on the roof.

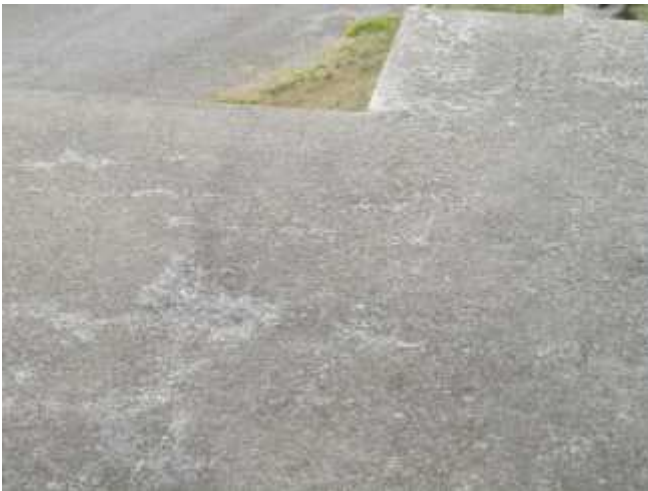
Surface pitting noted on the exposed roof concrete.

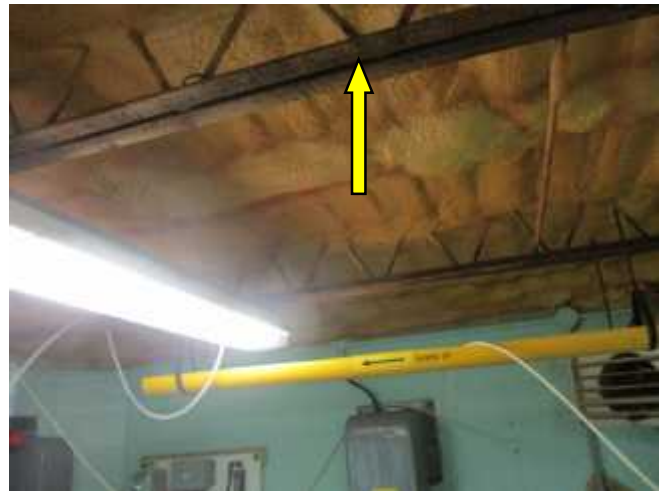
Heavy corrosion noted on the open web steel joist systems supporting the roof decking.

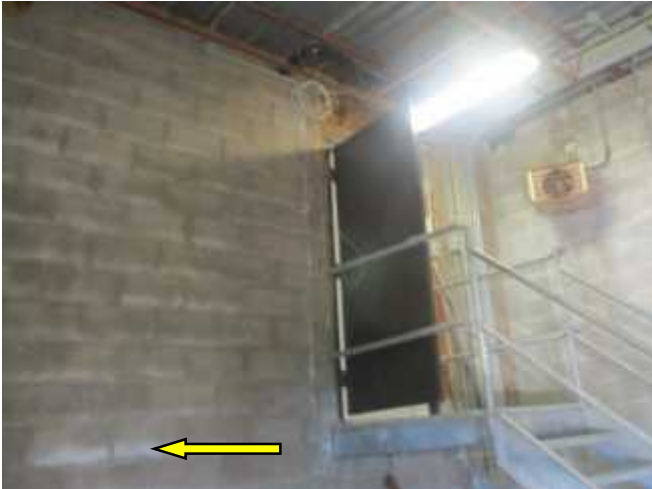
Moisture staining and efflorescence were noted on the interior walls of Building A.

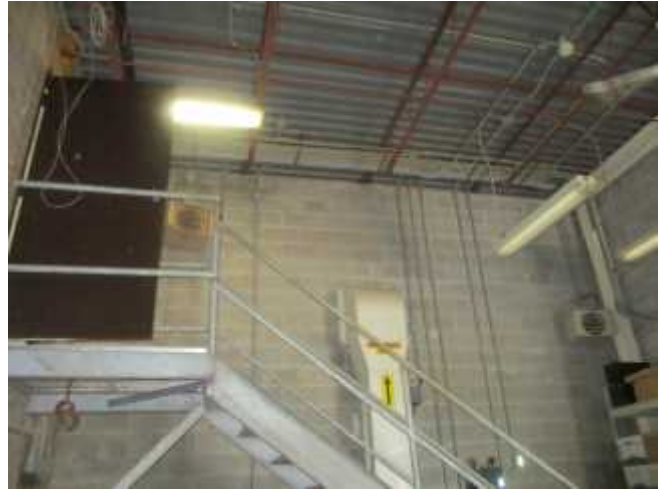
The east and south walls appeared in better condition than the west wall.

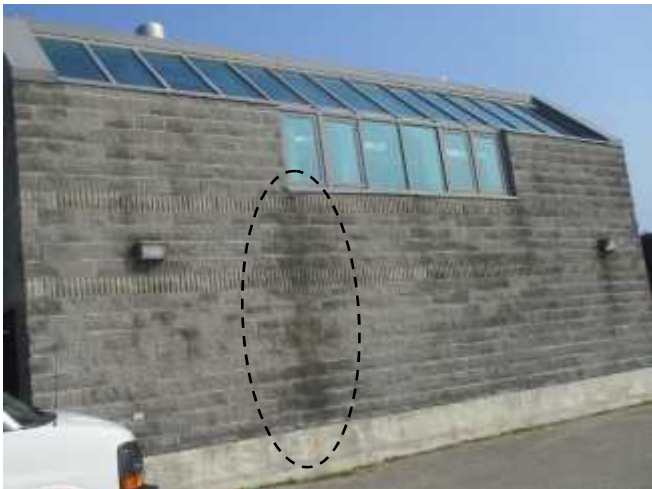
Moisture stained walls on the south elevation of Building B.

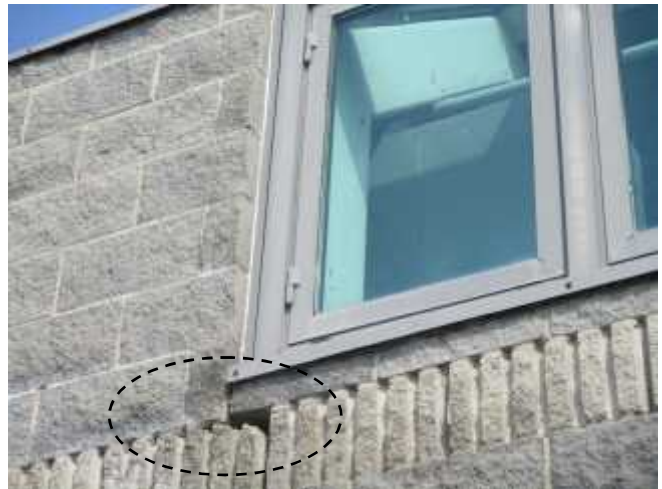
Missing mortar was noted below corner of the window.

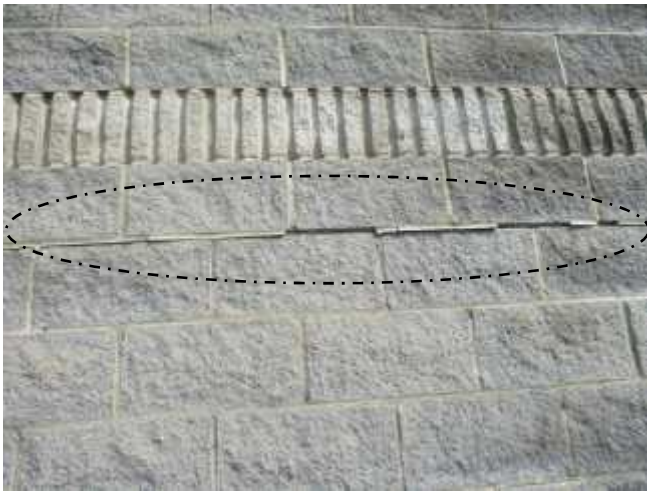
Areas of damaged mortar joints were noted on all elevations of Building B.

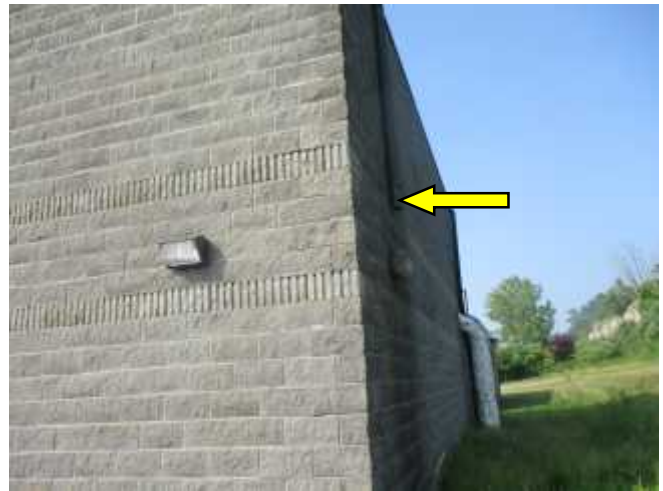
Missing piece of a downpipe on the north elevation of Building B.

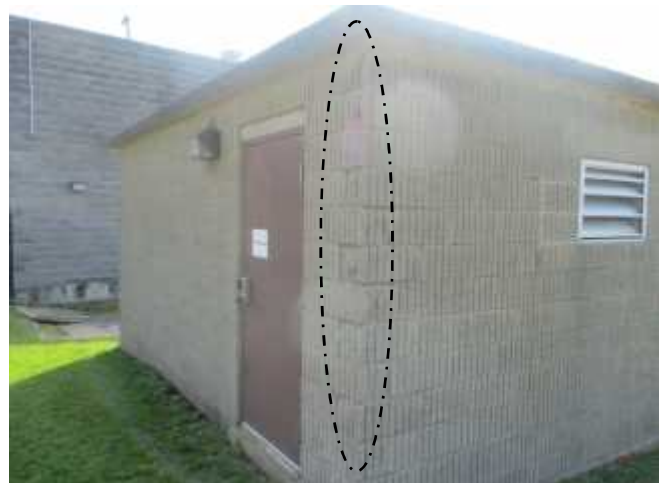
Spalled concrete blocks on the northwest corner of Building C.

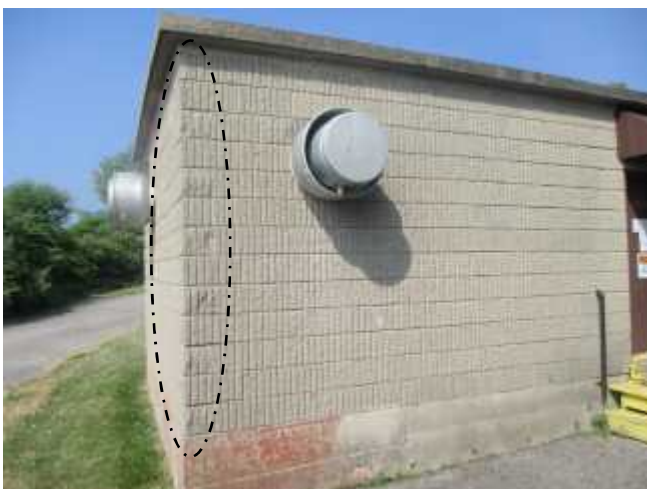
Spalled concrete blocks on the southeast corner of Building C.

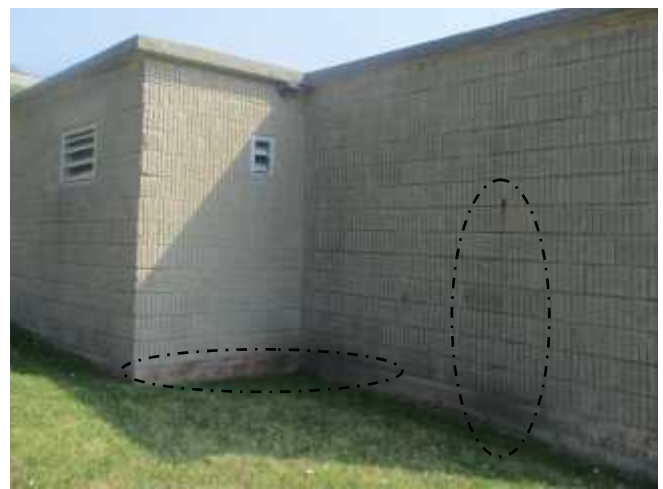
Moisture staining and damaged on the north elevation of Building C.

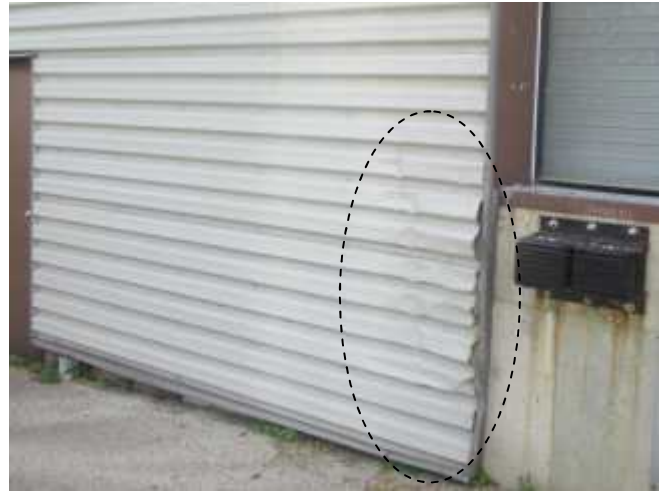
Impact damage on the cladding on the west elevation of Building A.

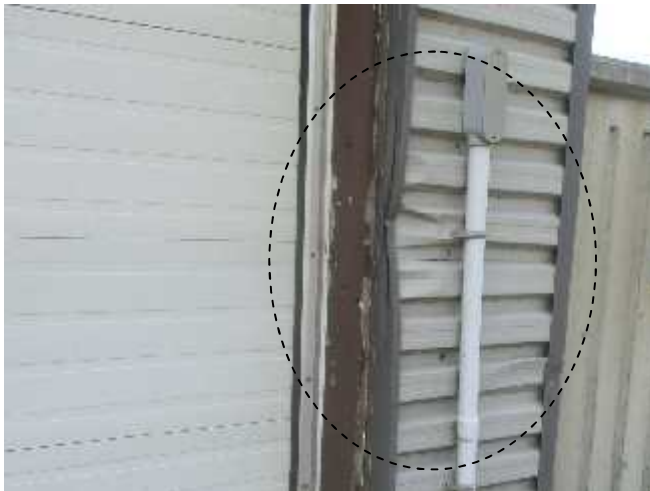
Damaged siding on the north elevation of Building A.

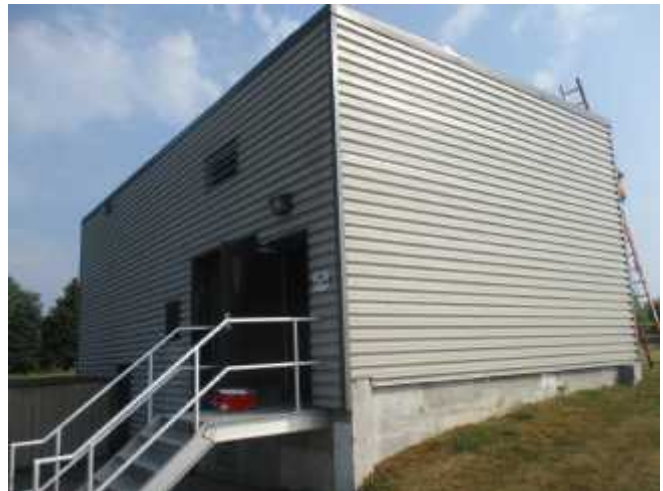
Prefinished metal siding on the south elevation was noted to be in good condition.

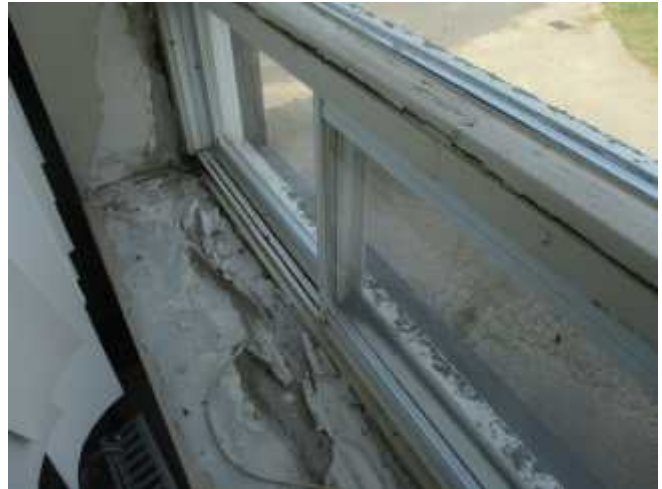
Evidence of heavy leak and mould growth on the window frame was noted on the north face of Building A.

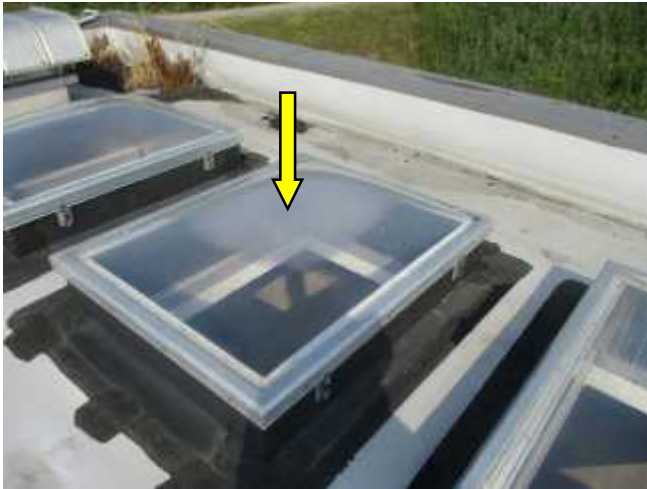
Presence of condensation between the panels of the skylight indicates failure of the hermetic seal.

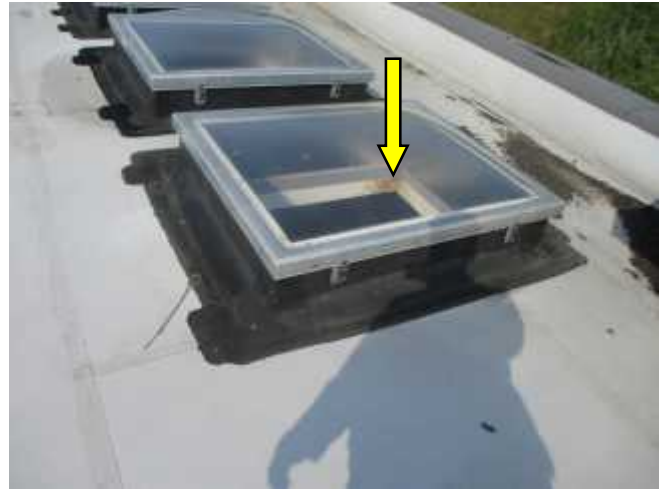
Moisture staining on the inner side of the skylight opening indicates leakage, likely caused by failure of perimeter sealant.

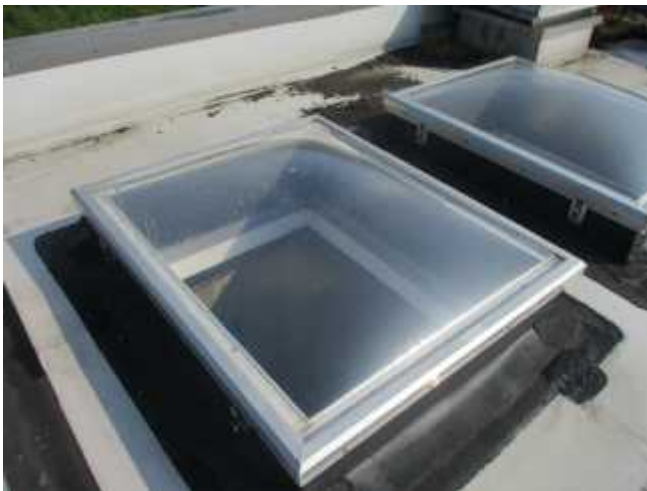
Apart from the two, all other skylights were noted to be in fair to good condition.

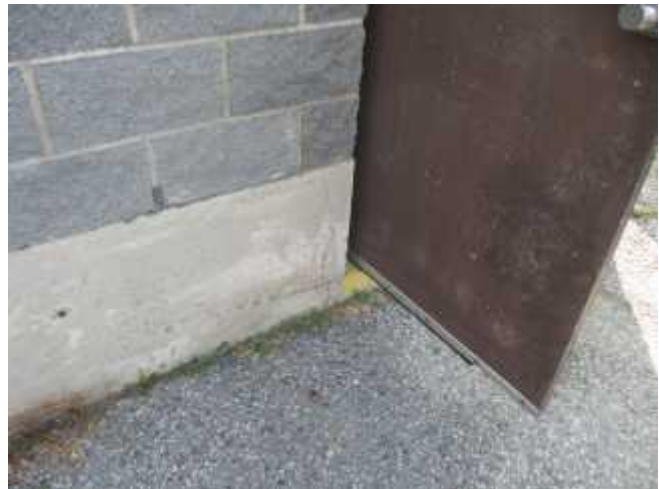
Fading and deteriorated finish on entrance of Building B.

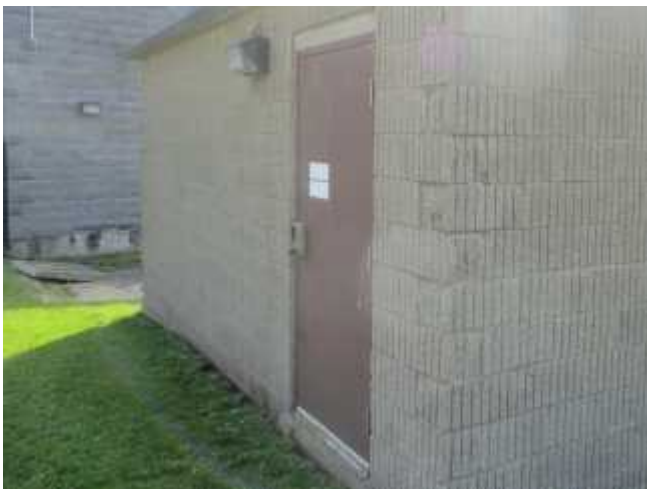
Secondary entrance door to the basement of Building C was noted to be difficult to operate.

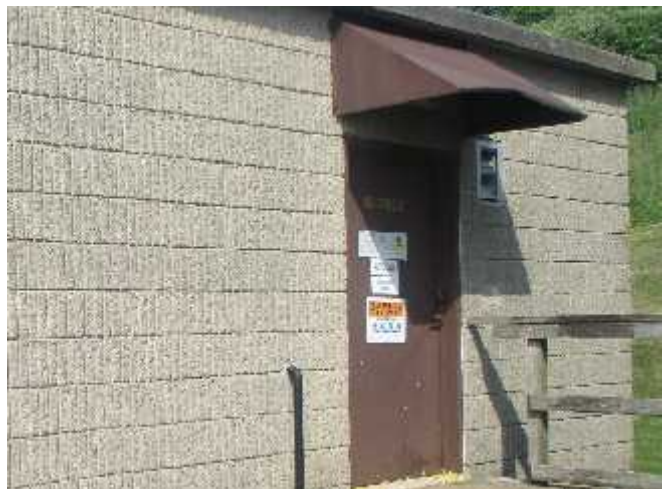
Corrosion was noted on the main entrance door and door hardware of Building C.

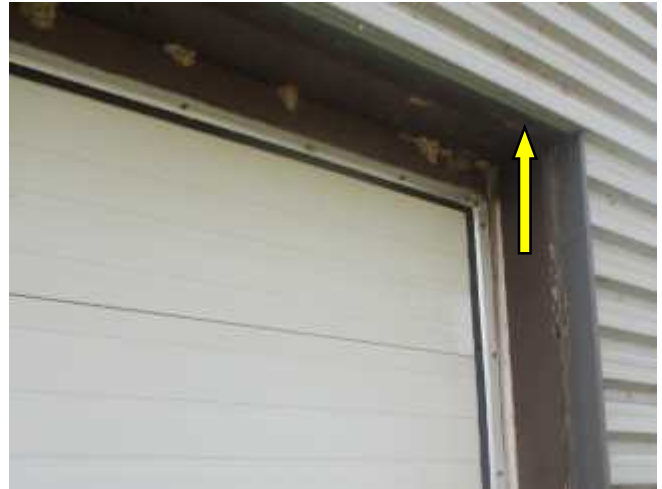
Deteriorated sealants at perimeter of a garage door of Building A.

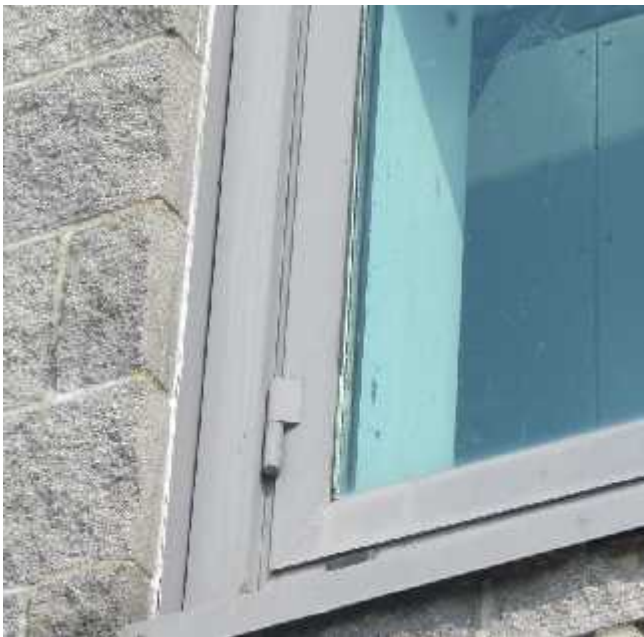
Split sealants around the windows of Building B.

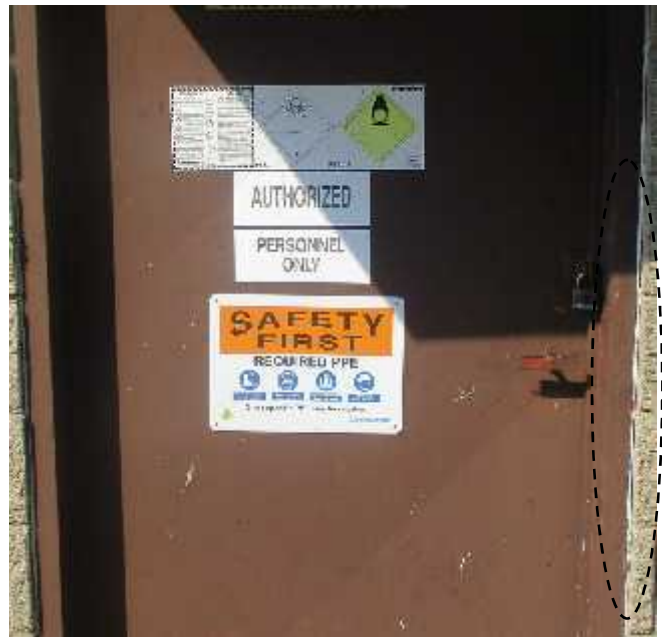
Deteriorated sealants at the door perimeter of Building C.

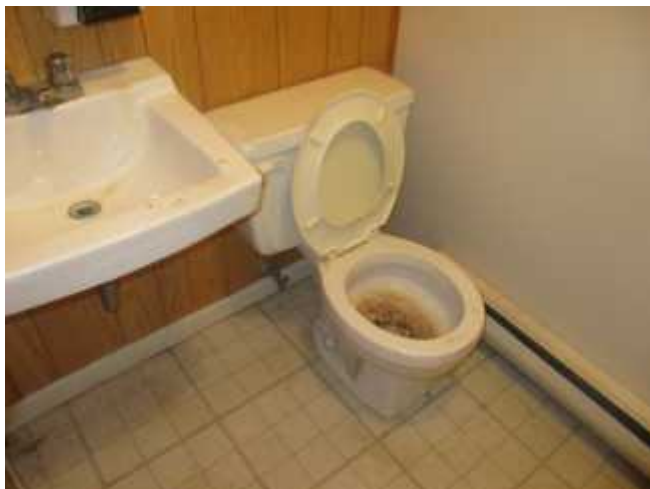
The bathroom fixtures and finishes appeared in poor condition.

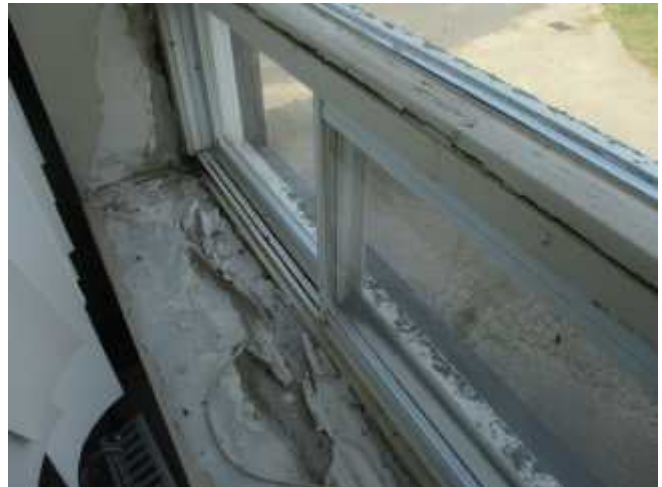
Moisture damage on the window sill on the north portion.

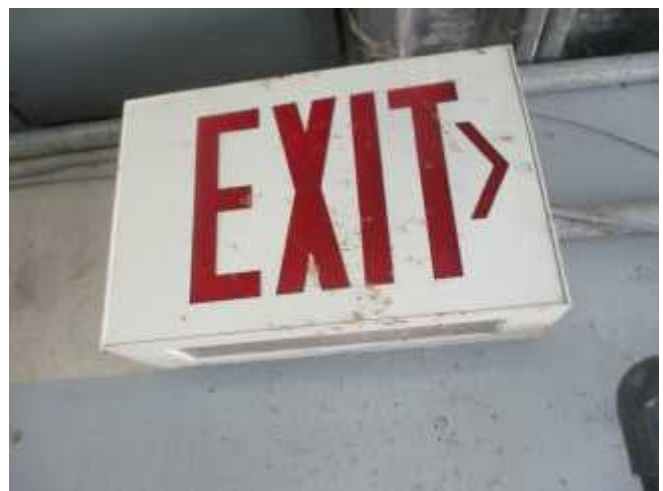
An exit sign with burnt-out light bulb in Building B.

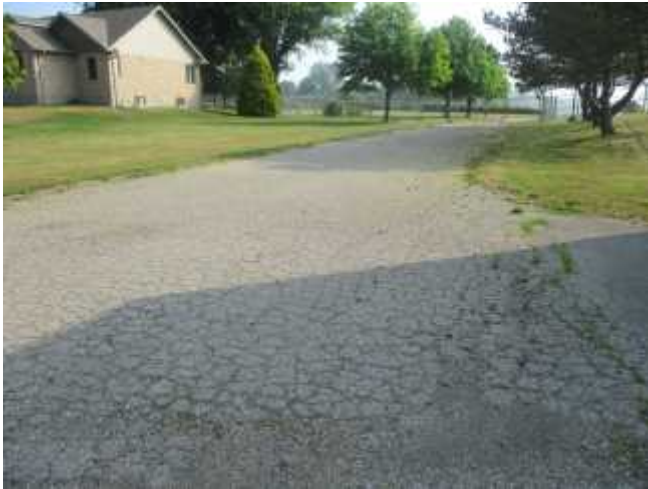
Asphalt pavement deterioration manifested in the form of severe alligator cracking on the north portion of the site.

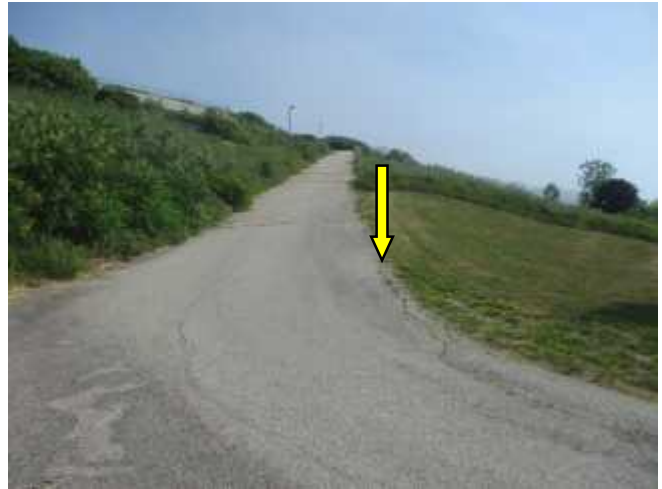
General view of asphalt pavement roadway at the central portion of the site. Areas of longitudinal cracks noted.

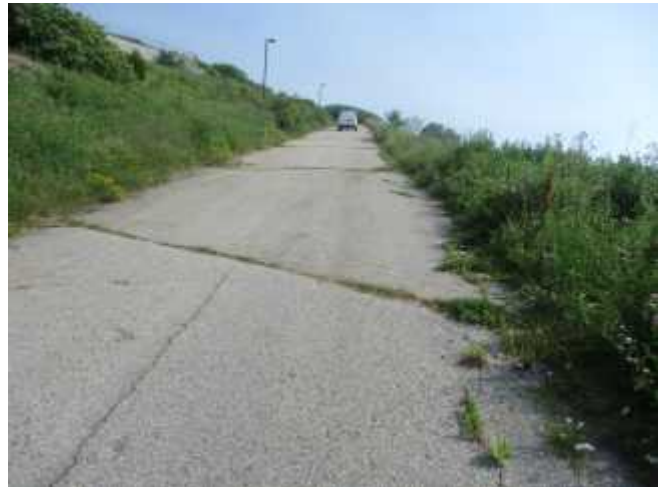
Cracking and growth within the cracks of the asphalt pavement.

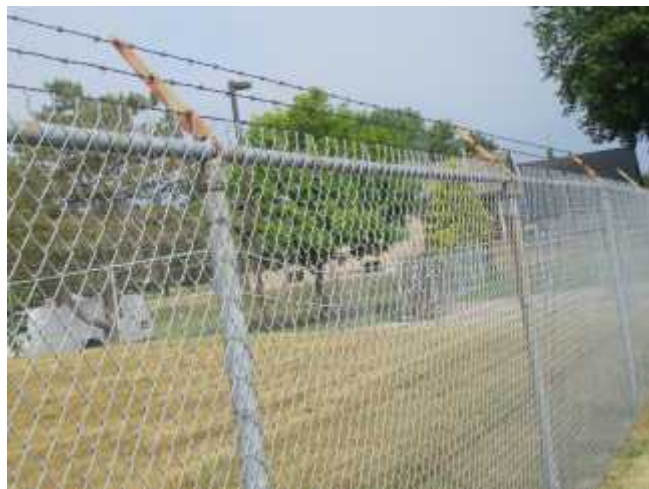
Areas of corrosion noted on the posts.

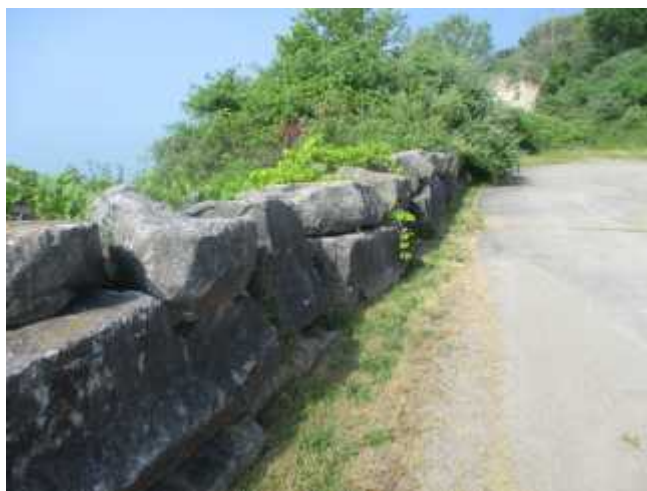
Shifted and leaning units were noted on the south wall.

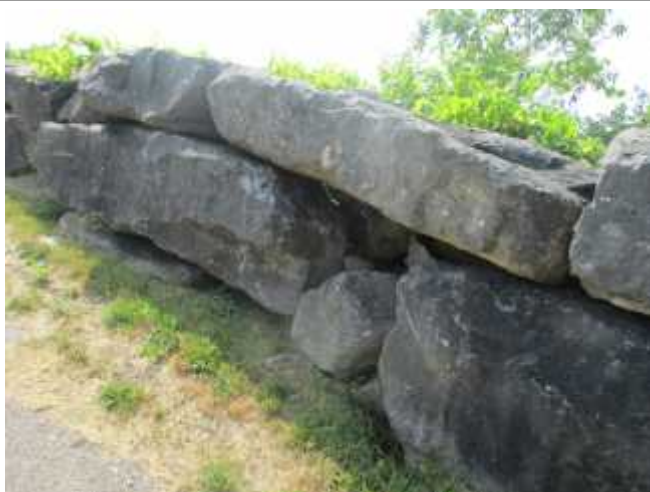
Evidence of minor erosion and shifted units observed at the south wall.

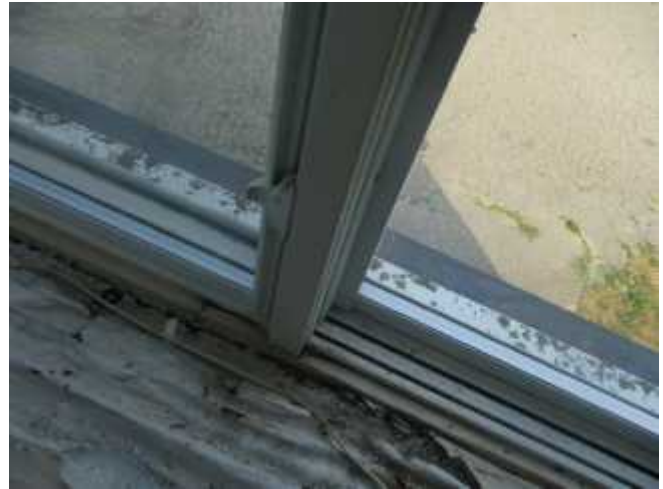
Mould growth is evident on the exterior face of window frame.
