# Tri-County Water Board of Management Agenda

# Building Condition Assessment & Capital Reserve Fund

## Service Buildings in West Lorne Ontario 8662 Graham Road, West Lone, Ontario

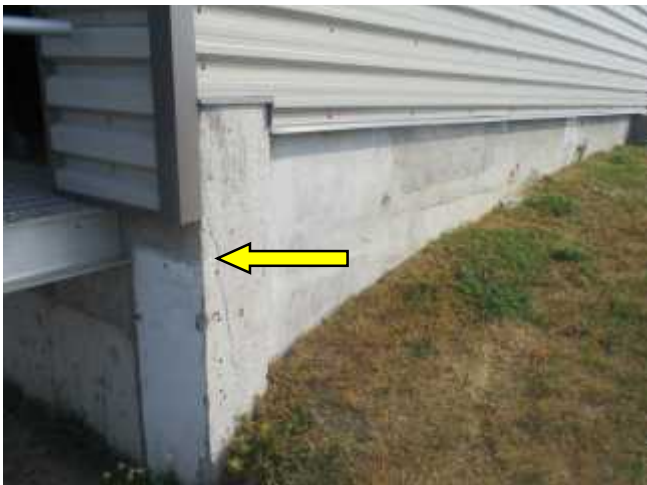
Minor cracking was noted on the foundation wall.

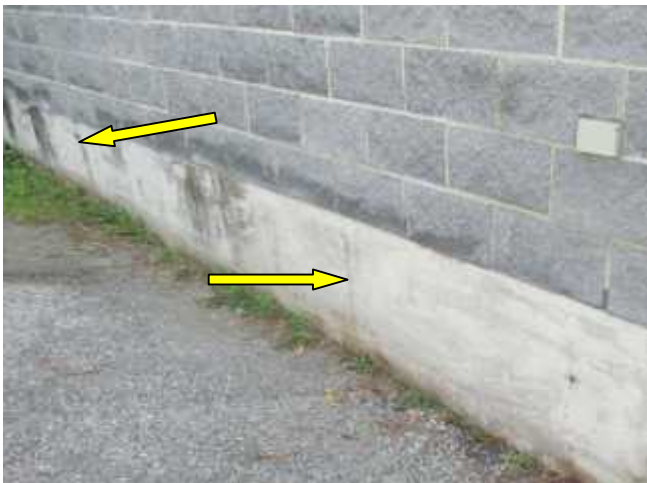
Surface cracks minor delamination and moisture staining were noted on the exterior face of foundation walls.

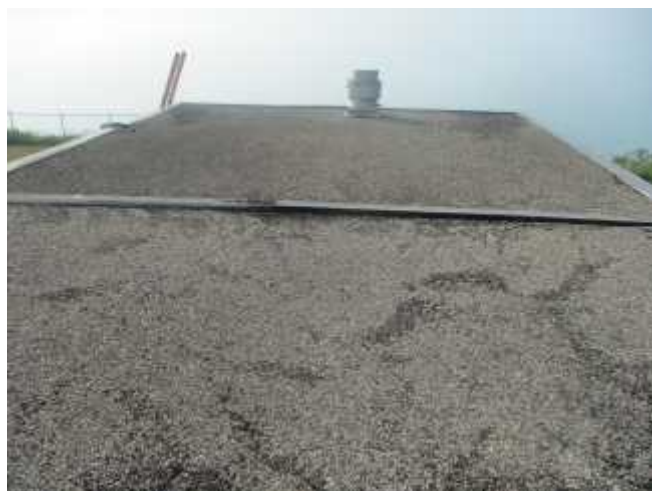
General view of the BUR system atop Building A.

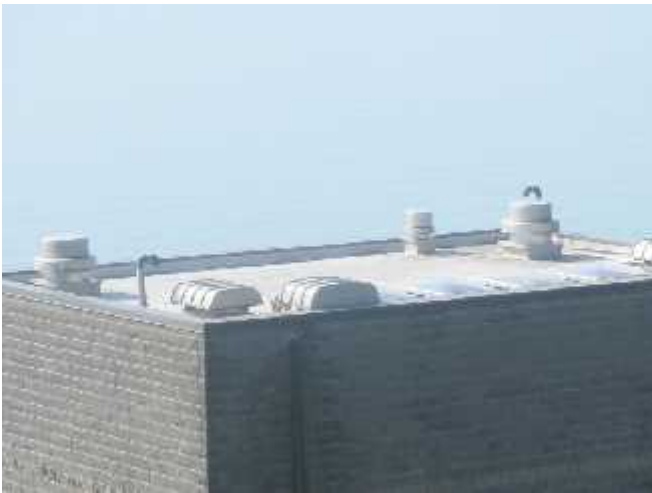
General view of the PVC membrane atop Building B.

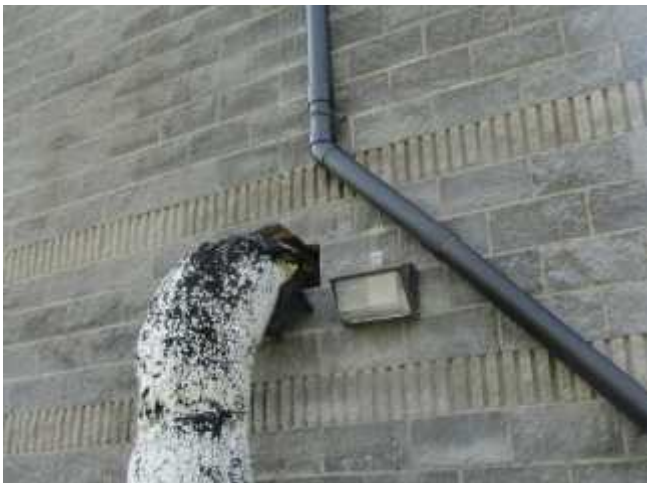
Unsealed pipe-penetration on the north wall of Building B.

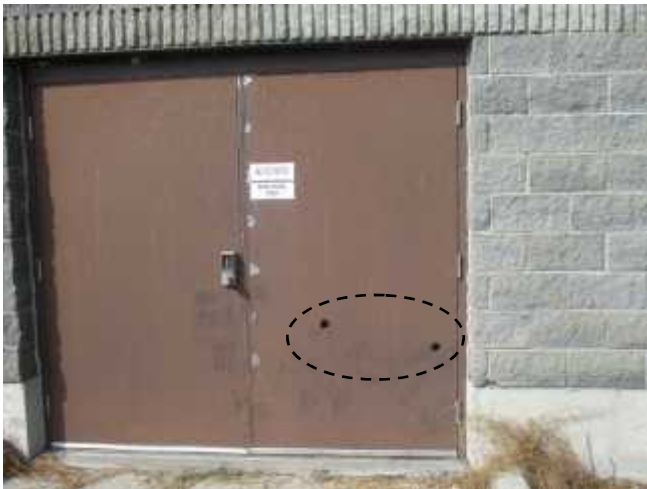
Unsealed holes on the secondary entrance door of Building B.

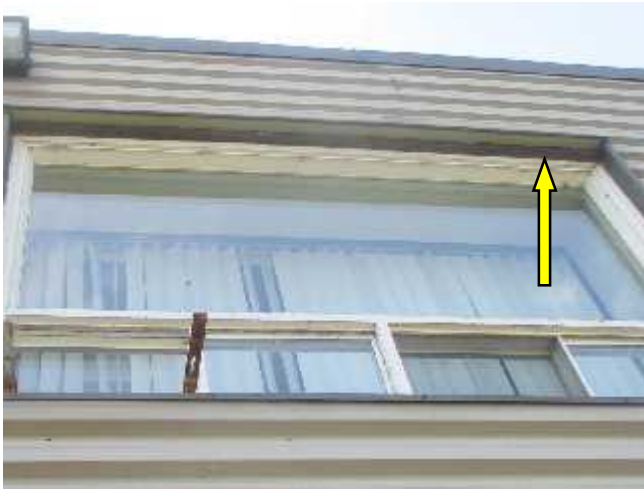
Window perimeter sealants were noted to be in poor condition in Building A.

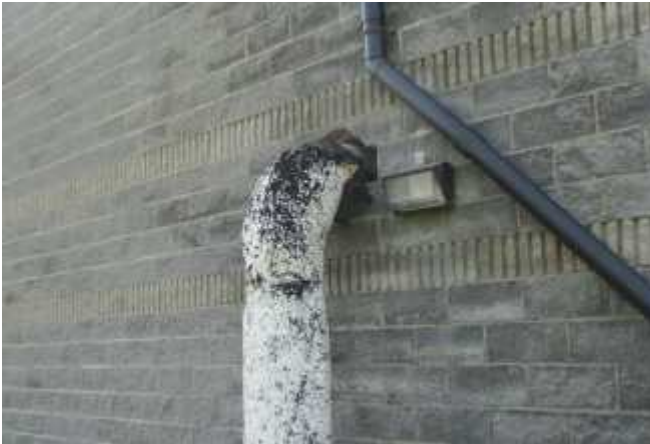
An unsealed pipe penetration on the exterior wall of Building B.

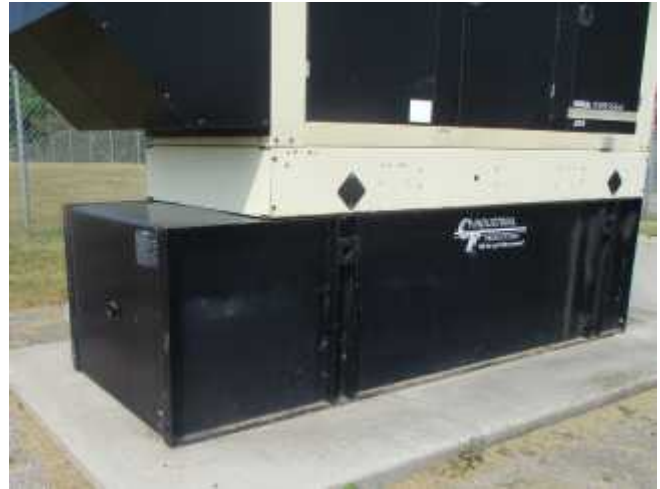
Generator storage tank.

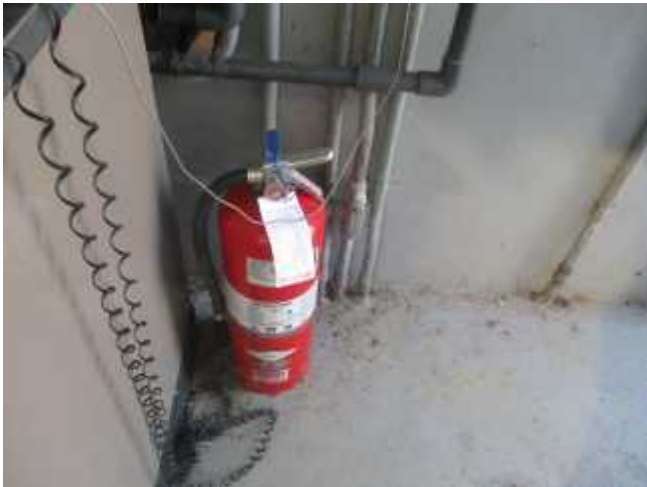
Fire extinguisher on the mezzanine level of Building B.

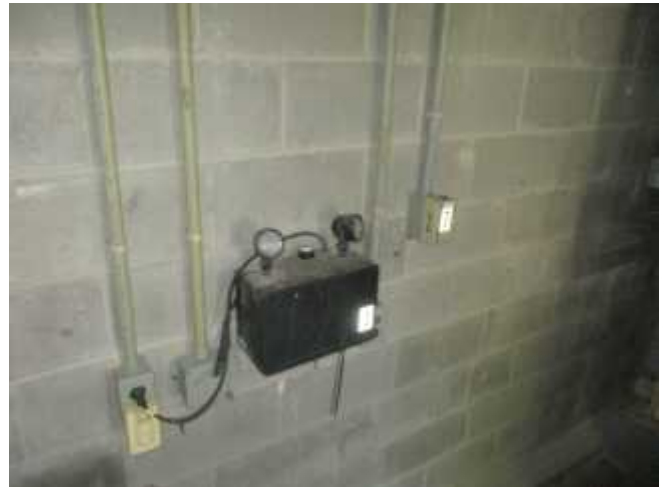
Typical emergency light and battery pack located within Building A.

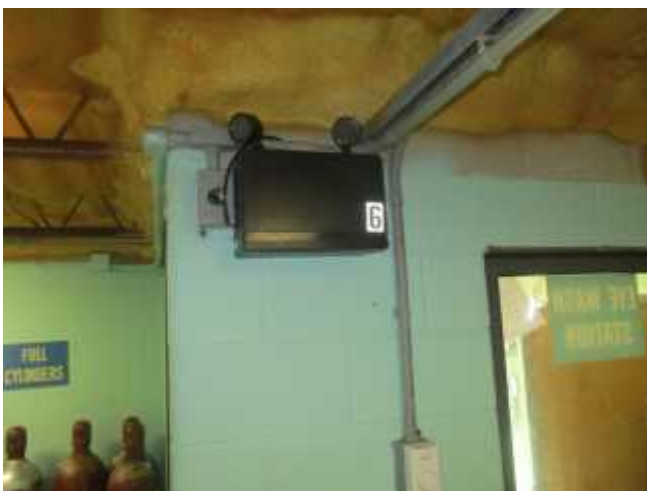
Typical emergency light and battery pack located within Building B.

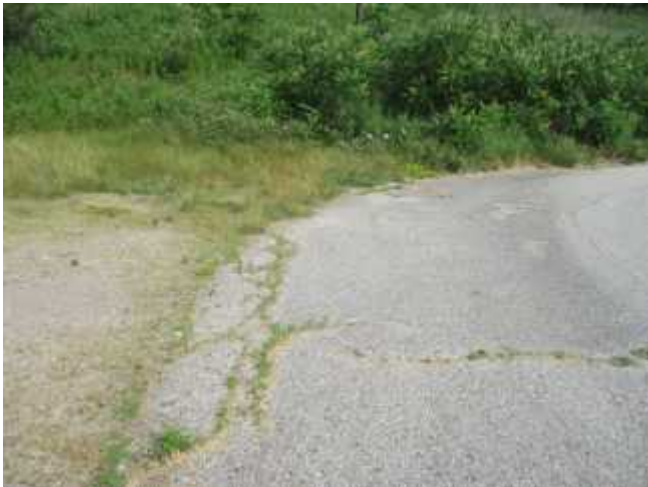
Cracking and growth within the cracks of the asphalt pavement.

Summary Budgetary Costs				
Budgetary Cost (2020)	Quantity	Expenditure Recommended	Expenditure Type	Summary Recommendation
\$165,000	27500 sq. ft.	2 - 5 Years	Recommended	An allowance for repaving of the site asphalt.
Design & Specification Recommended: <input type="checkbox"/> Project Management & Quality Control Recommended: <input checked="" type="checkbox"/>

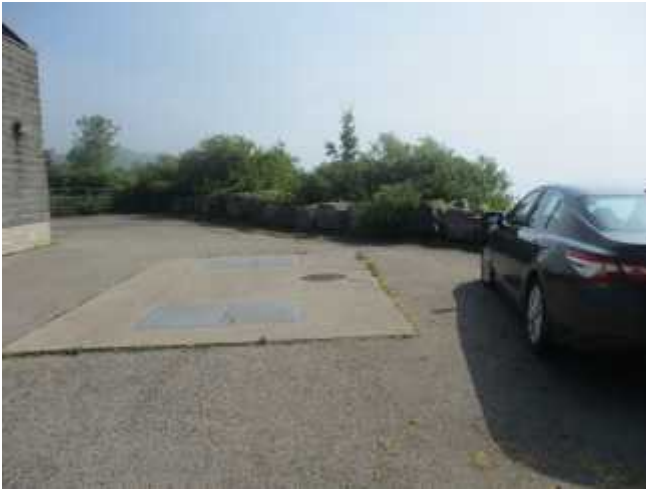
Concrete pad adjacent to the south elevation of Building B, likely atop an underground storage tank was noted in good condition.

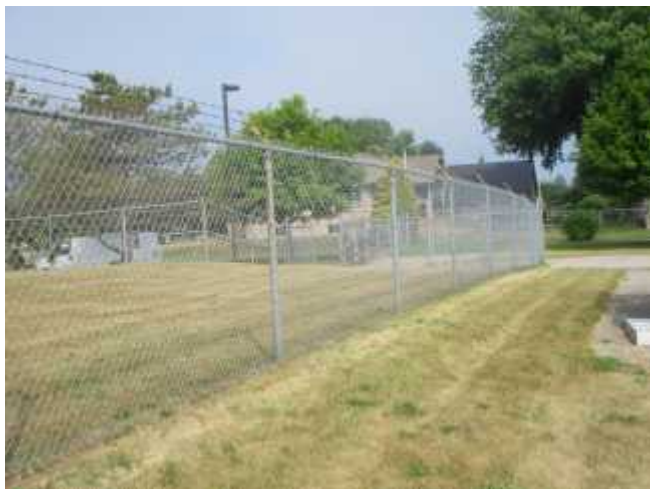
General view of the fencing south of Building A.

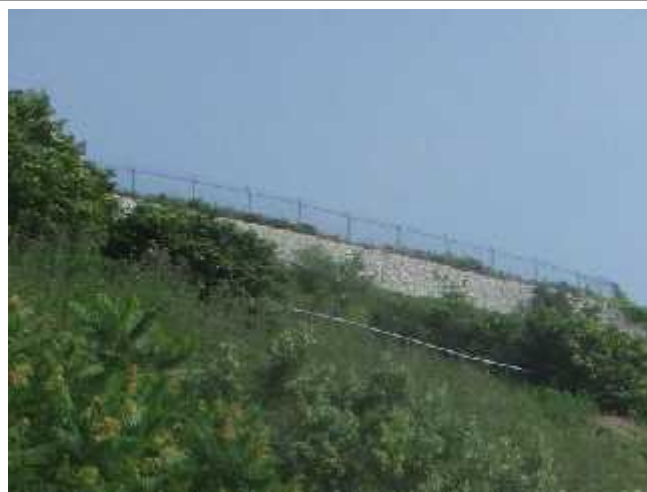
General view of the Gabion style retaining wall in the middle portion of the site.

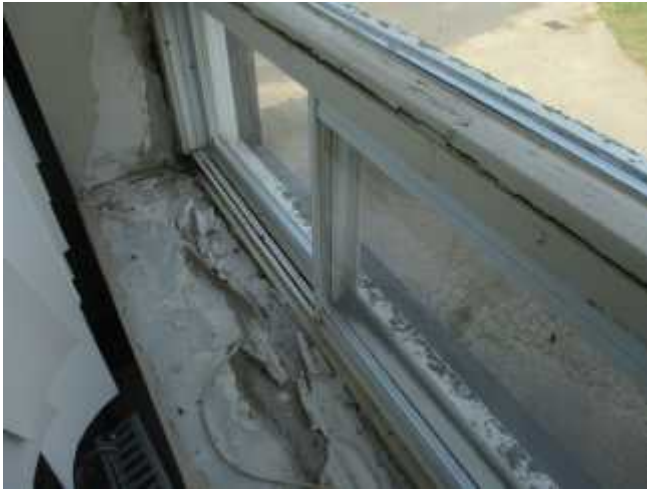
Damaged window sill of Building A where mould growth is suspected.

General Comments
<ul style="list-style-type: none"> <li>- Mould assessment surveys should be conducted by a qualified Environmental Engineer.</li> </ul>
